Subject: Monitoring Well Abandonment
Saint Gobain Performance Plastics
McCaffrey Street, Hoosick Falls, New York
Amec Project No. 3410120904

Saint Gobain Plastics
Well Abandonment
Hoosick Falls, NY
January 2013

PHOTOGRAPH LOG

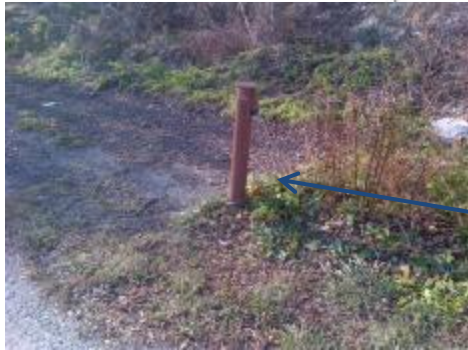
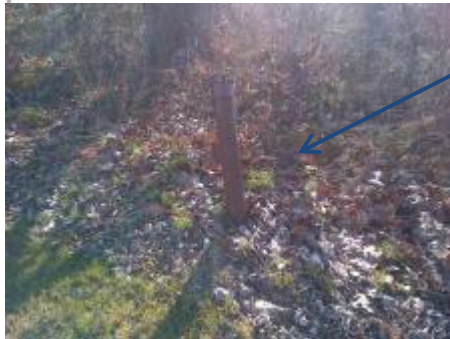
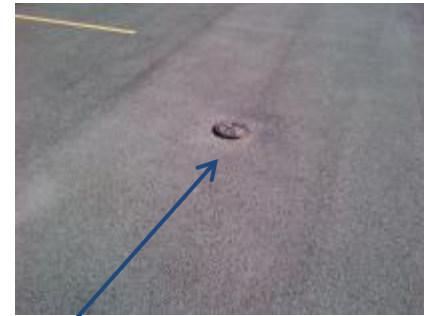
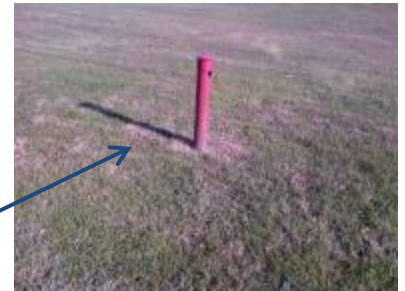
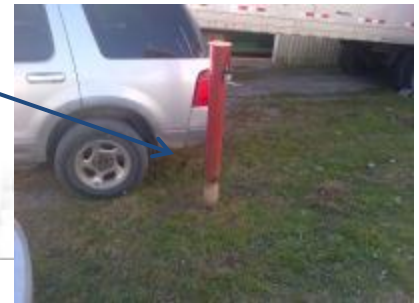
ATTACHMENT 2

Five groundwater monitoring wells designated MW-1M through MW-5M were abandoned; the depths of the five wells ranged from 5 to 20 feet. **Attachment 2** contains a figure that details the location and appearance of the wells.

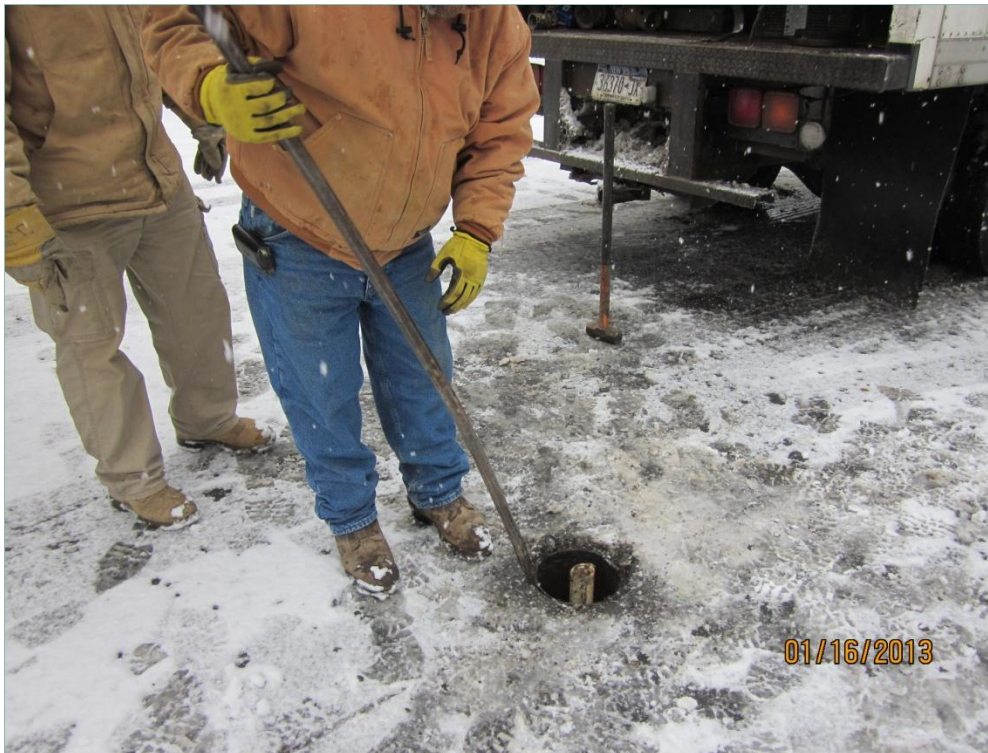
Photo 1

Well abandonment commences at MW-1M located in the upper parking lot area at approx. 0900.

1. Removal of the protective steel surface casing (wells MW-2M through MW-5M) or well vault (MW-1M). MW-1M was installed in a paved area flush mounted with the pavement.

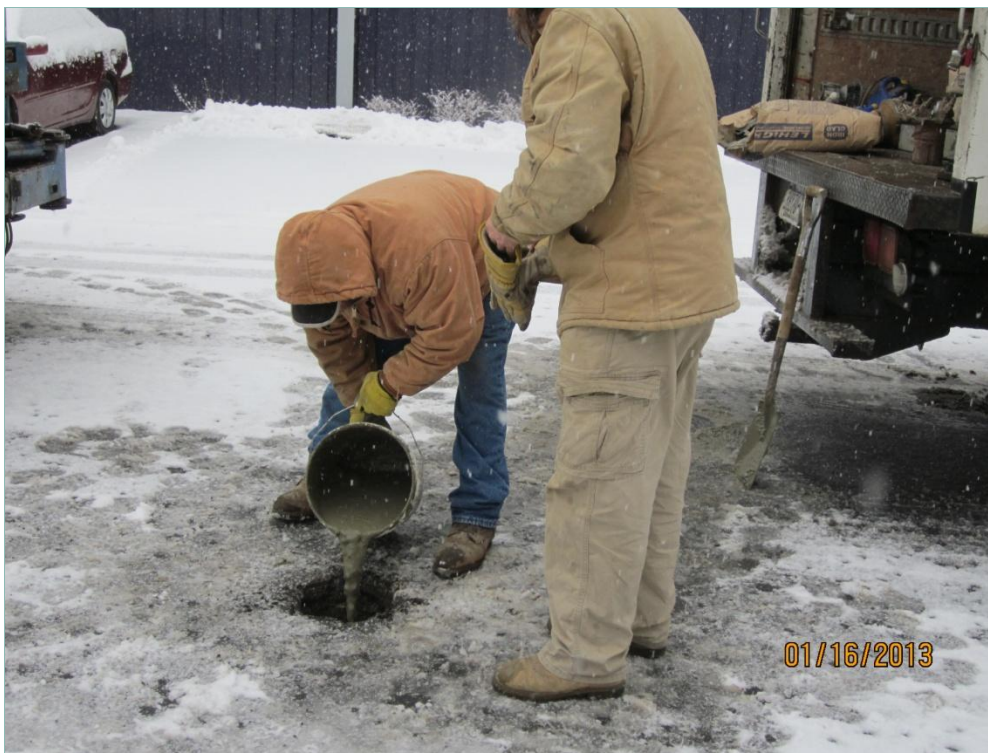
Photo 2

The curb box at MW-1M is removed and the PVC piping is cut to ~ 1 ft below grade. The well is grouted to the surface.

3. The wells were abandoned by backfilling the casing and borehole (MW-4M) with cement-bentonite grout. Grout placement continued until the level reached and stabilized at the ground surface. Special care was taken in the abandonment of MW-1M (located in the asphalt parking lot) to ensure that the final grout level was even with the asphalt surface. Orange construction cones were placed around the abandoned well to protect the grout from vehicular traffic. The traffic cones were left in place for approximately 48 hours to allow sufficient time for the grout to set.

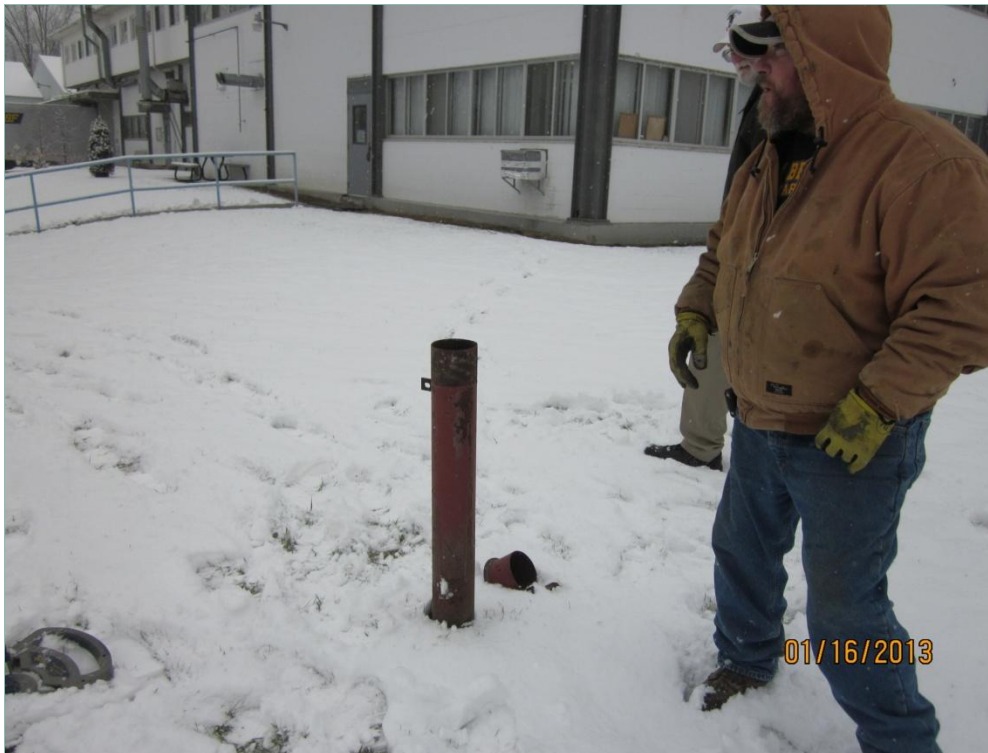
Photo 3

Abandonment commences at MW-2M located along the eastern edge of the Site.

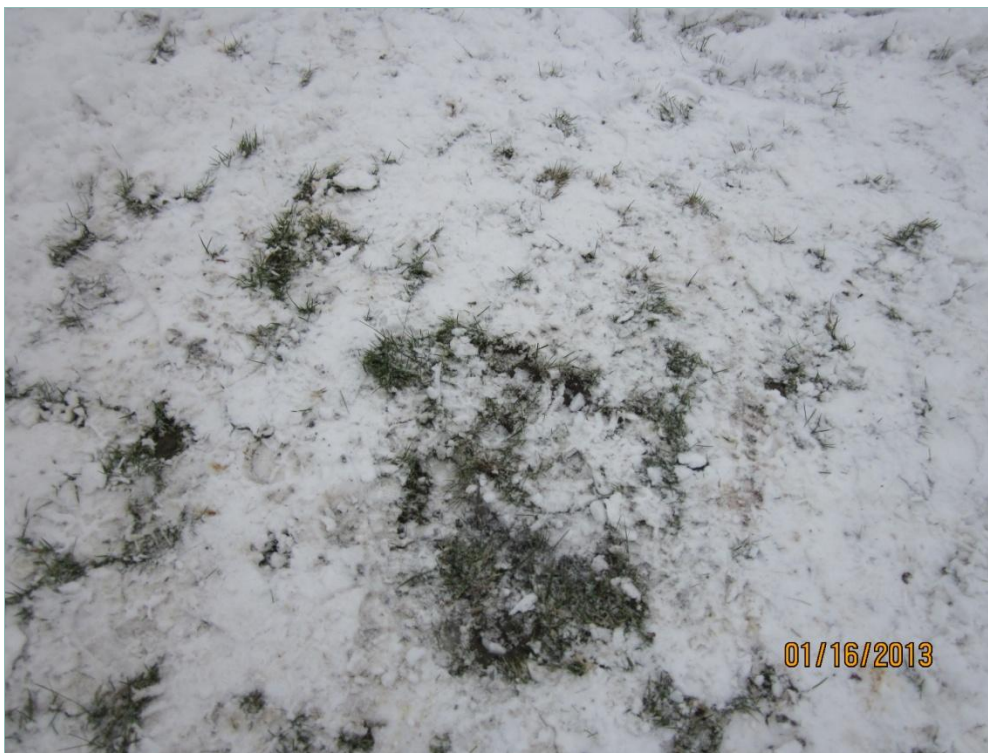
Photo 4

The riser pipe is removed from MW-2M, the PVC is cut to ~ 1 ft below grade and the well is grouted to the surface.

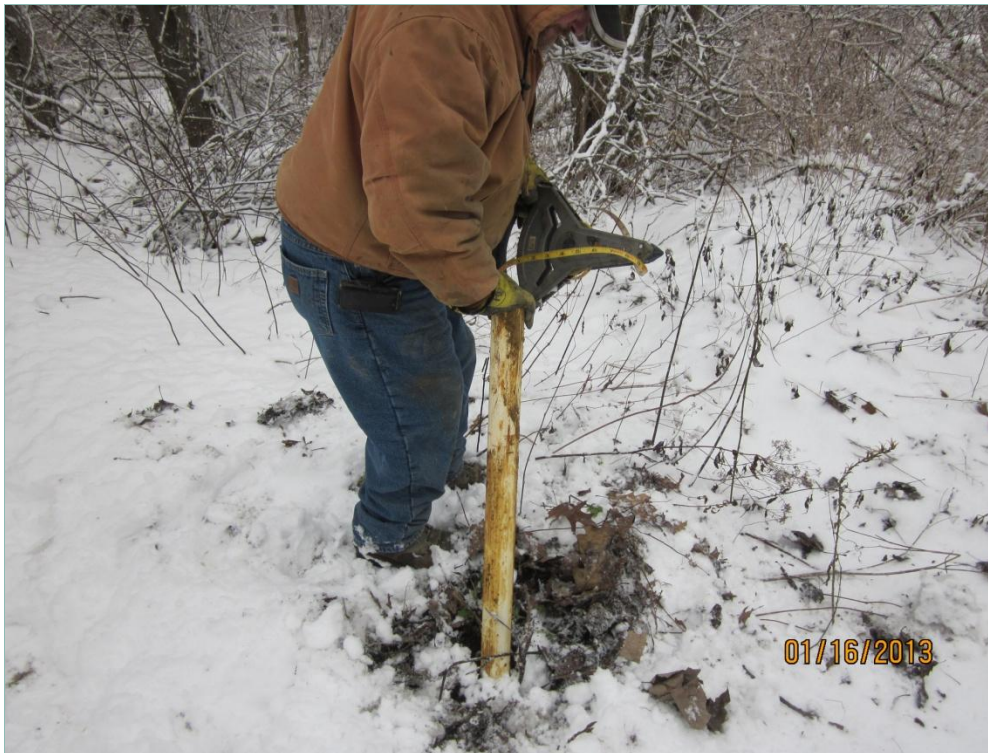
Photo 5

Abandonment of MW-3M is underway. The riser pipe is removed and the PVC is cut to ~ 1 ft below grade. The well is then grouted to the surface.

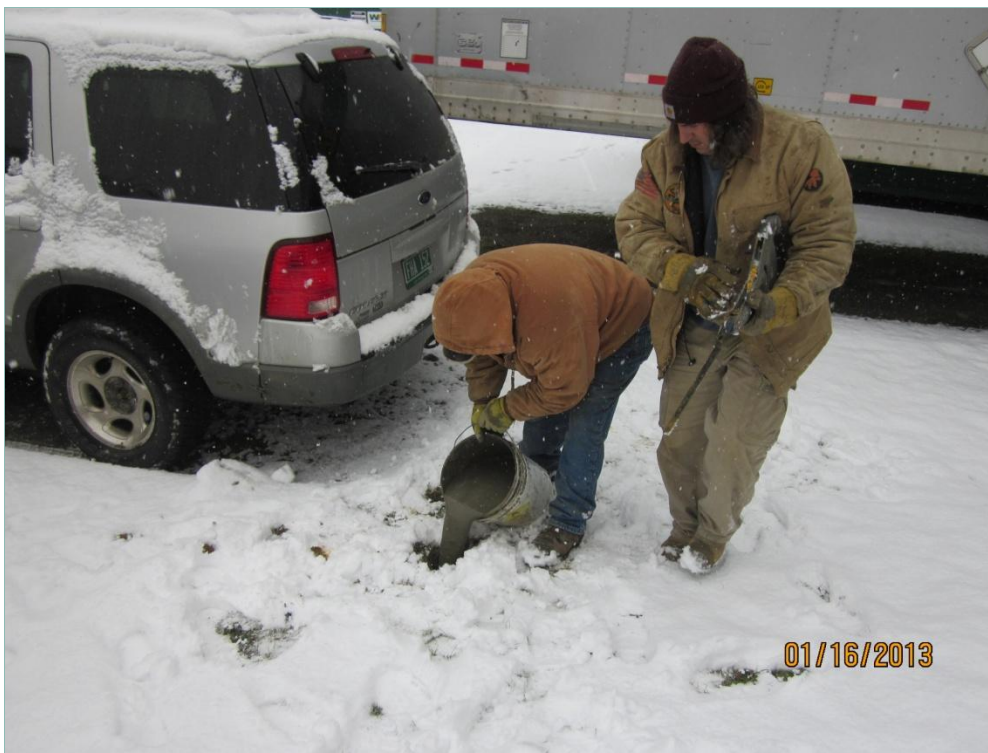
Photo 6

Abandonment of MW-5M is underway.

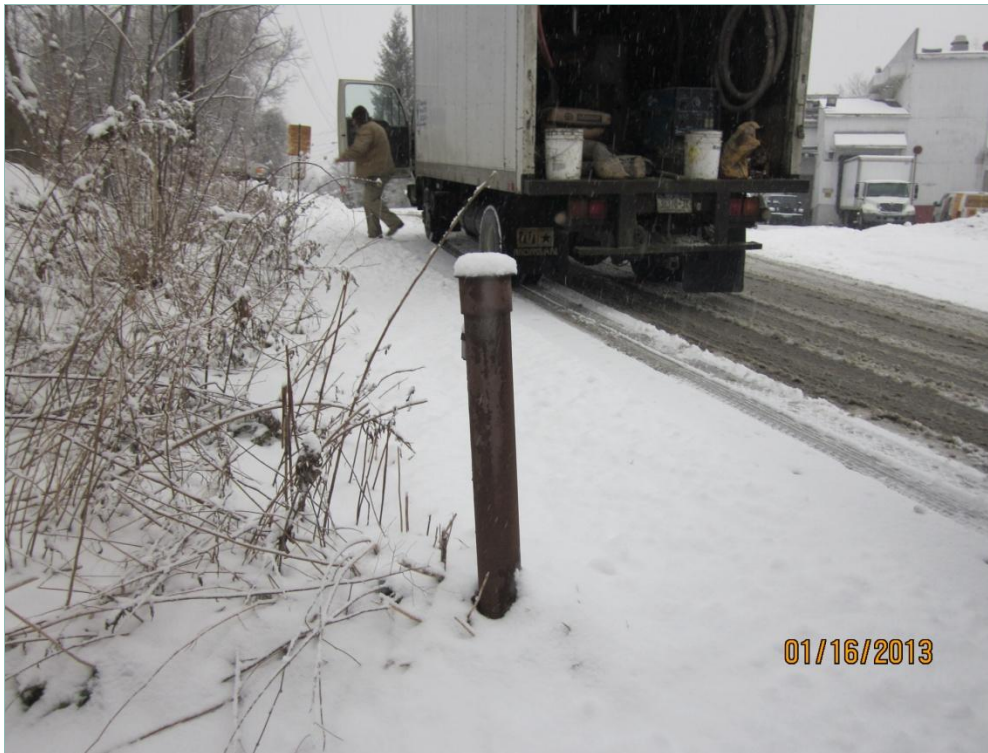
Photo 7

MW-4M, located on the western edge of the site along the access road, prior to abandonment.

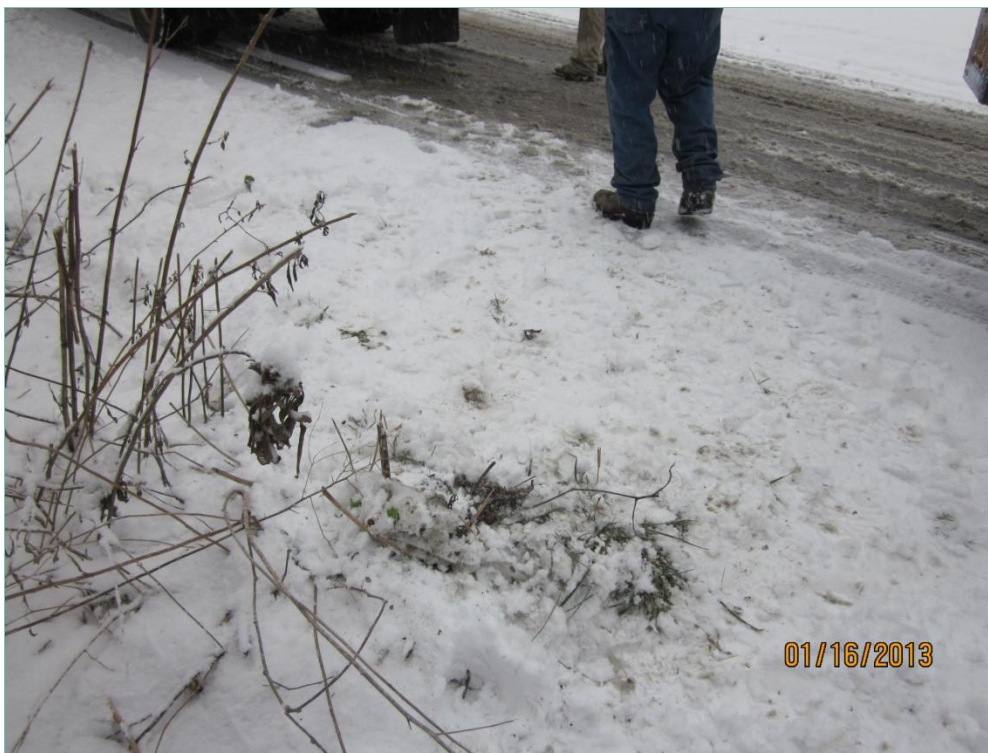
Photo 8

The riser pipe and PVC piping were completely removed and the well was grouted to the surface.

2. With the exception of MW-4M, the well boreholes were excavated to a depth of approximately 1 foot below existing grade. Following excavation, the 2-inch PVC well casing was cut off at the excavation depth. For well MW-4M, the entire length of well casing was able to be pulled from the borehole.
